Navajo Abandoned Uranium Mine

Site Screen Report

Mine Name: Earl Huskon No. 1
Mine ID: 178

August 2011

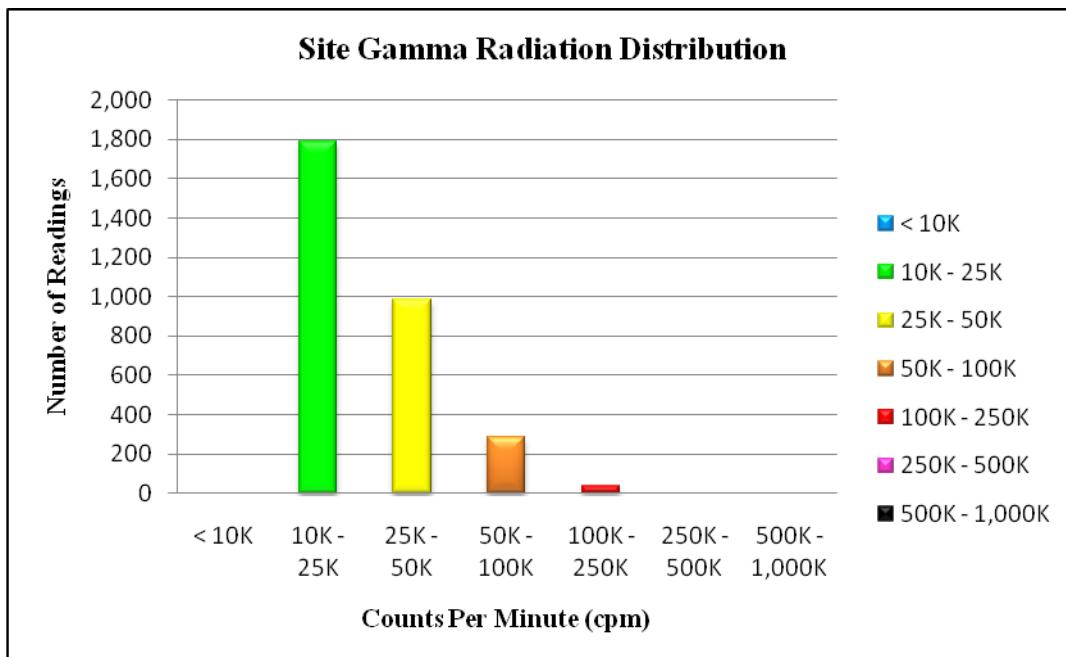
Highest gamma radiation measurement: 224,505 counts per minute (cpm)

Background Average: 17,041 cpm **Two Times Background:** 34,082 cpm

A total of 3,098 gamma radiation measurements were collected from the mine site, ranging from 10,897 cpm to 224,505 cpm. Measurements collected in the vicinity of the waste rock were found at a maximum level of approximately 225,000 cpm, and the reclamation area of approximately 70,000 cpm. The measurements are represented in Figures 1 and 2.
